# ANNUAL REPORT FOR 2011

**Jeffreys Warehouse Stream Mitigation Site**  
**Wayne County**  
**TIP No. R-1030AA**

Prepared By:  
Natural Environment Unit & Roadside Environmental Unit  
North Carolina Department of Transportation  
August 2011

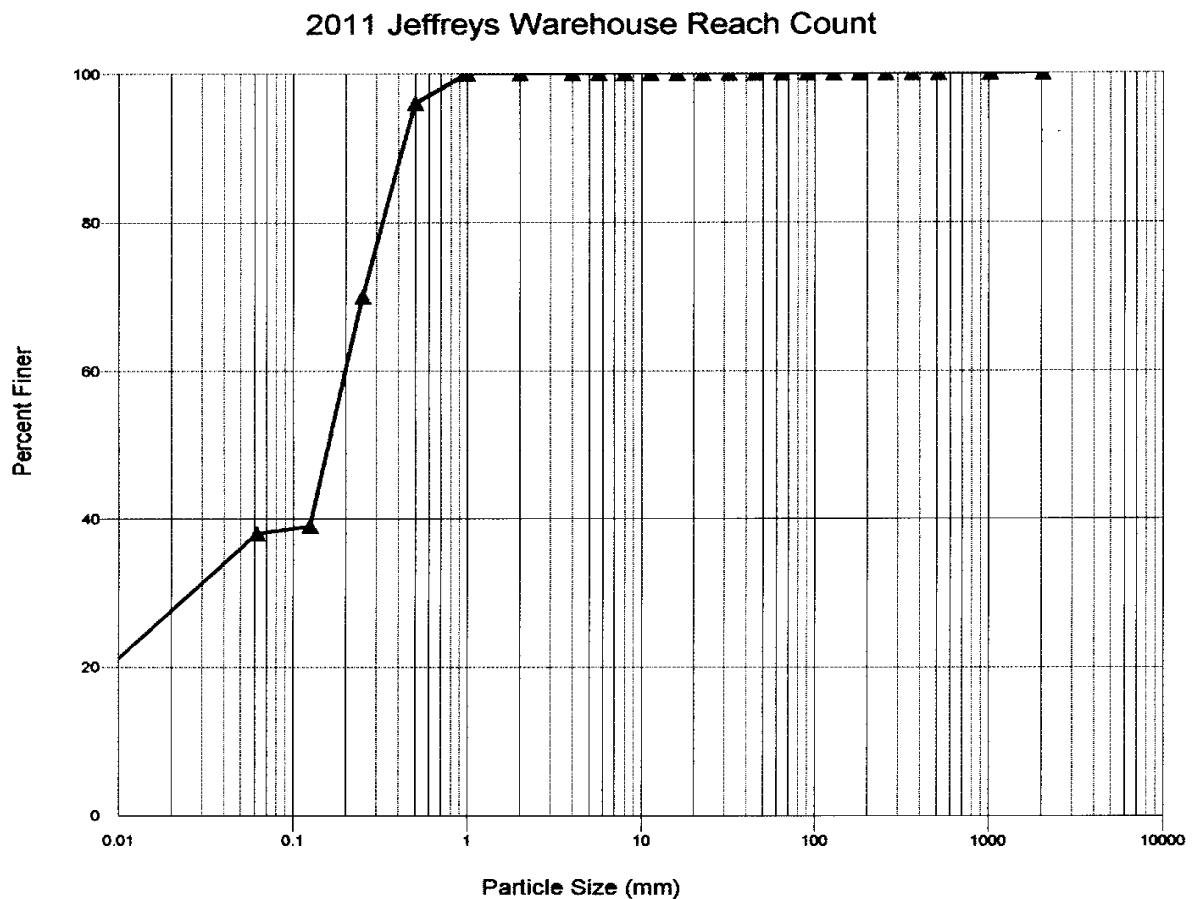
**Chart 1. Particle Size Distribution for Entire Reach**

A representative pebble count was taken throughout the surveyed reach. This information is used to determine the stream type. Jeffreys Warehouse Mitigation Site was designed as a sand bed system with the  $D_{50}$  being less than one. The pebble counts taken during the Year 2011 monitoring period noted that the  $D_{50}$  (50 percent of the sampled population is equal to or finer than the representative particle diameter) for the entire reach of Jeffreys Warehouse Mitigation Site was approximately 0.17 mm, which is indicative of a sand-bed stream.

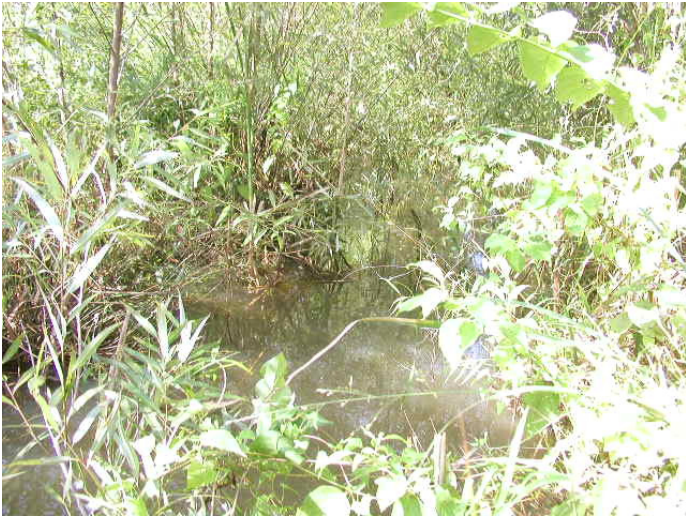
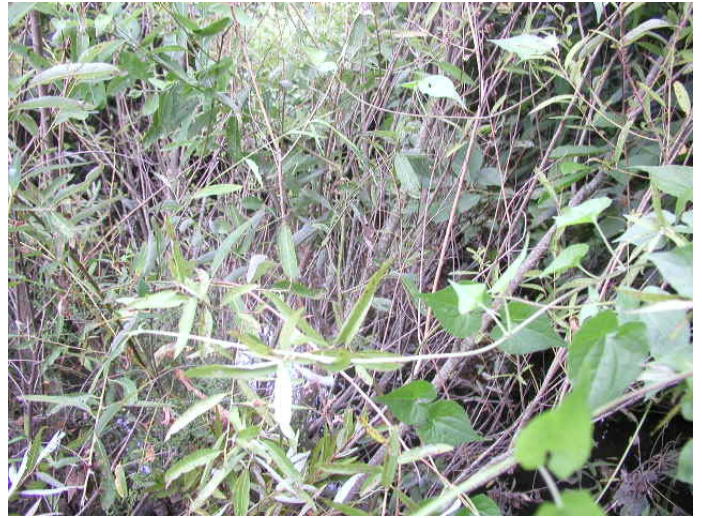
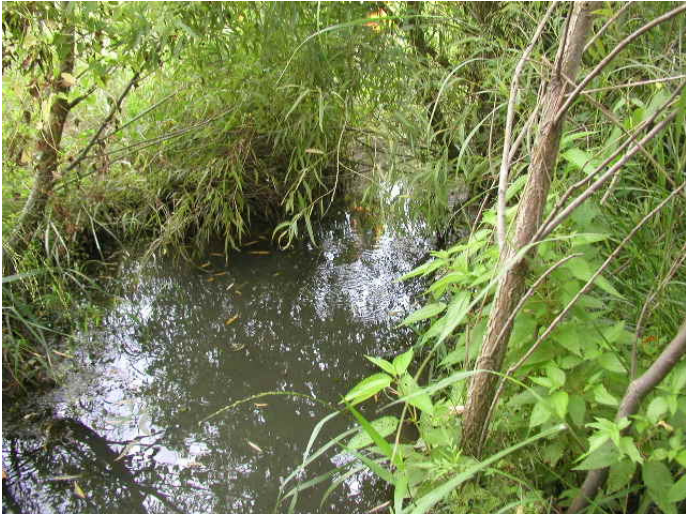
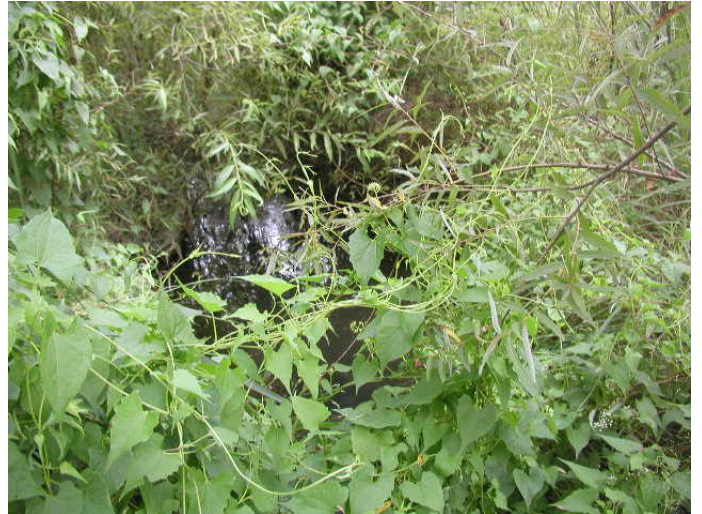
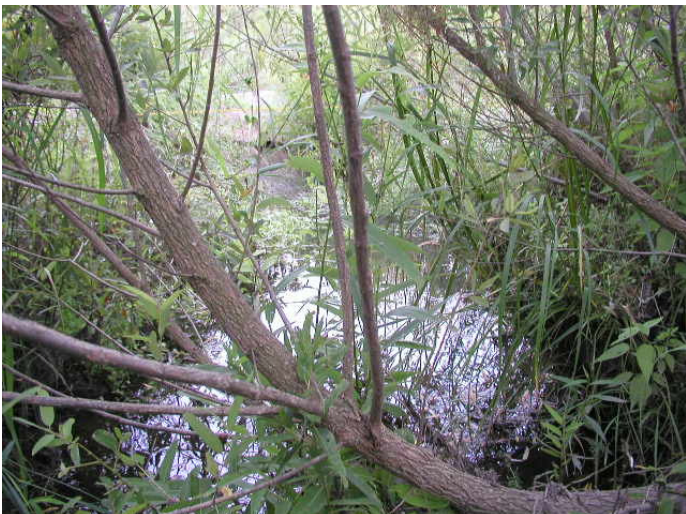
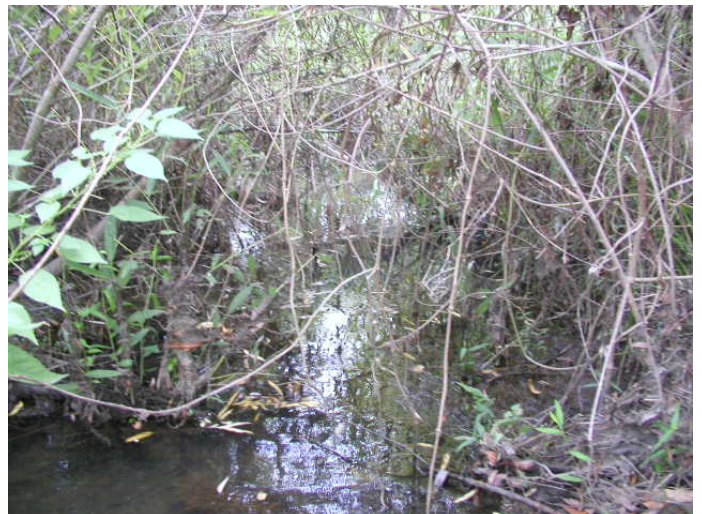
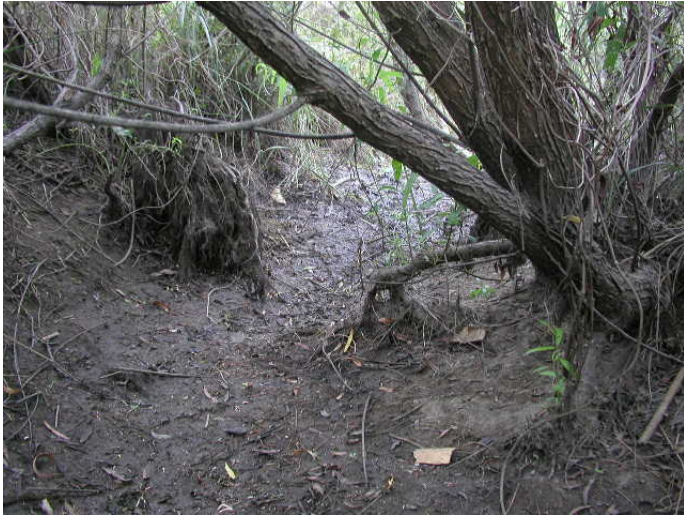
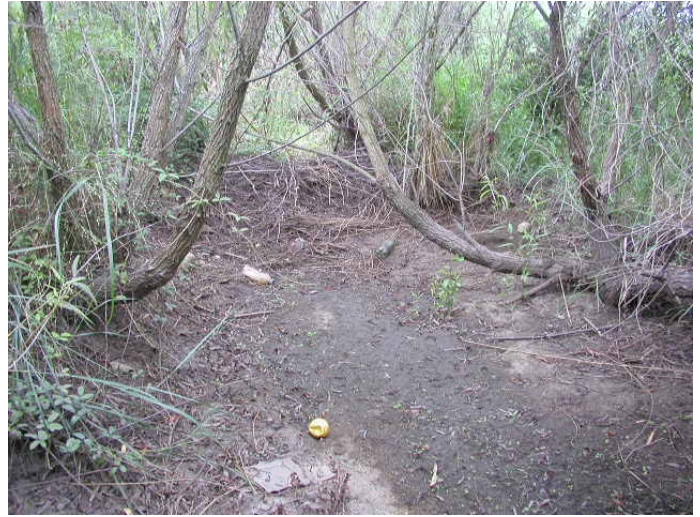
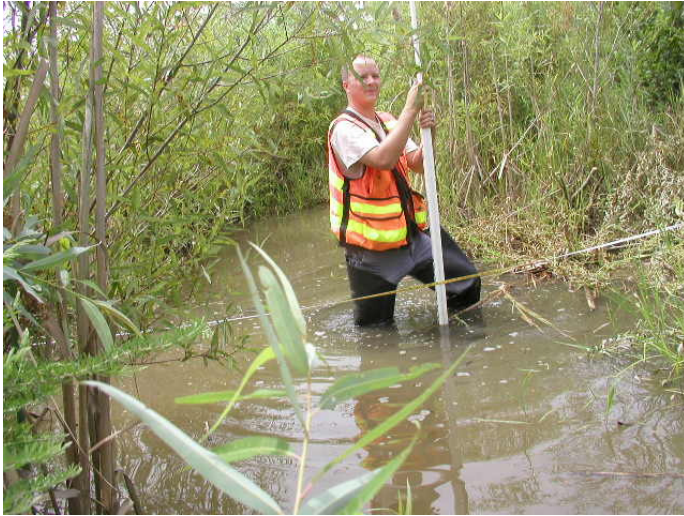
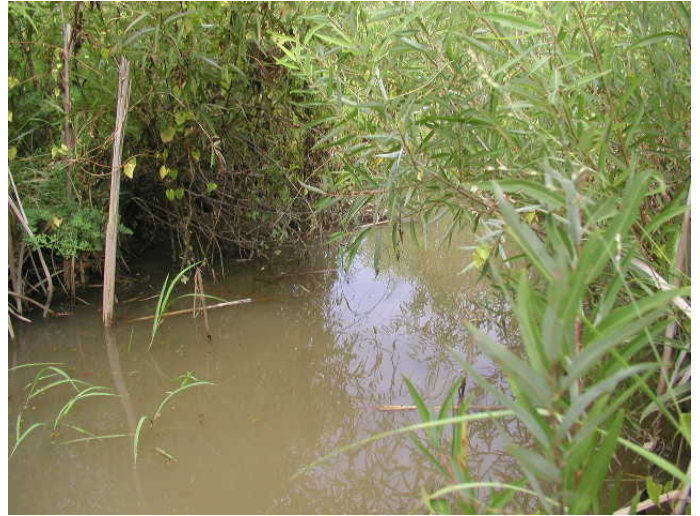
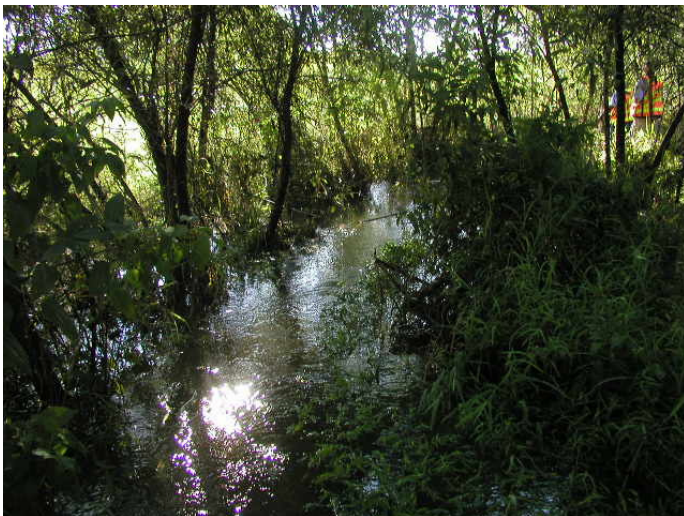
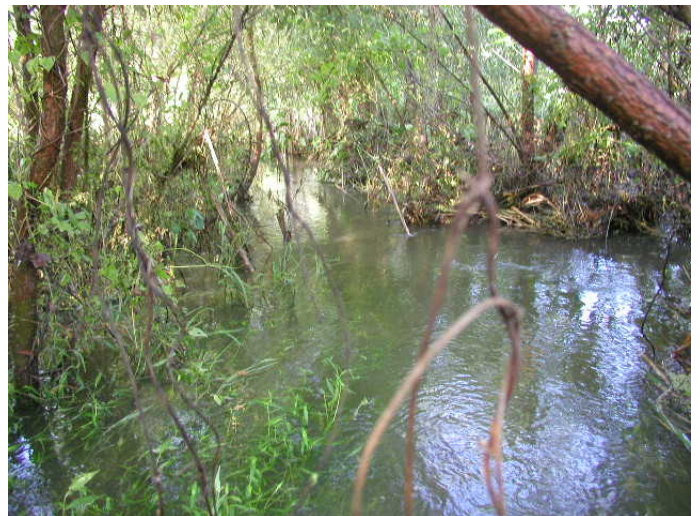
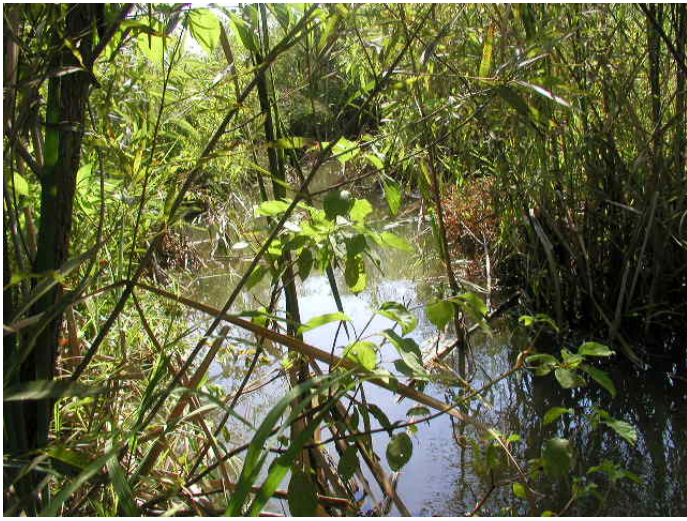
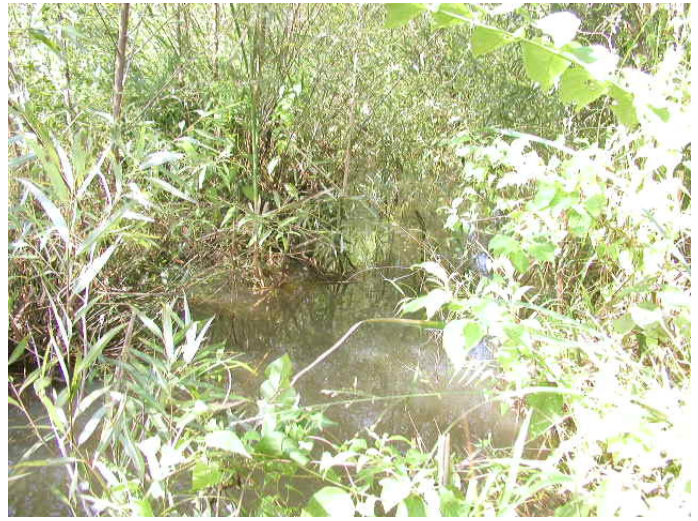
Photo points 1 through 7 showed an extensive growth of herbaceous and woody vegetation. The channel bed is stable throughout the stream restoration project. An old beaver dam was located just upstream of cross section #8. Water surface shots were not taken at cross section #8 due to no water flow within this section of the stream. Cross sections 11 through 14 were shot on day two of our field work and water was out onto the floodplain at these cross section locations due to heavy rainfall from the previous night. NCDOT has contracted USDA to trap the beavers and breach the beaver dams throughout the monitoring period.
